1. REPORT NUMBER	2. GOVT ACCESSION NO.	3. RECIPIENT'S CATALOG NUMBER
4. TITLE (and Subtitle) Investigation of the Accelerated Corrosion of Cupro-Nickel Piping		5. TYPE OF REPORT & PERIOD COVERED THESIS
7. AUTHOR(s) Brown, Jr., Martin R.		8. PERFORMING ORG. REPORT NUMBER
9. PERFORMING ORGANIZATION NAME AND ADDRESS Massachusetts Institute of Technology Cambridge, Massachusetts		10. PROGRAM ELEMENT, PROJECT, TASK AREA & WORK UNIT NUMBERS
11. CONTROLLING OFFICE NAME AND ADDRESS CODE 031 NAVAL POSTGRADUATE SCHOOL MONTEREY, CALIFORNIA 93940		12. REPORT DATE June 1979
14. MONITORING AGENCY NAME & ADDRESS (if different from Controlling Office)		13. NUMBER OF PAGES 83
		15. SECURITY CLASS (of this report) UNCLASS
		15a. DECLASSIFICATION/DOWNGRADING SCHEDULE

The accelerated corrosion (erosion) of 70/30 cupro-nickel alloy was investigated as a function of environment using a laboratory recirculation loop. The environments utilized were unpolluted artificial sea water and artificial sea water polluted with sulfides (Na_2S) and two different levels of ammonium ion (NH_4Cl). The use of ferrous sulfate (FeSO_4) as an inhibitor was also briefly examined. The results indicated that S^{2-} and NH_4

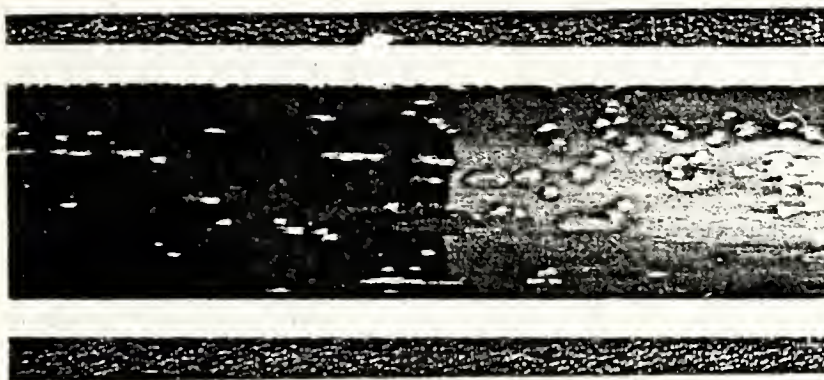
FIG. 11

SALT
HIGH NH_3

The SEM was used to analyze two samples which contained the surface films of interest, specifically the following: (1) thin, dark film, (2) thick, flaky film, (3) pit corrosion product, (4) reddish film, and (5) base metal inside a pit. Sample 4 (Salt + Sulfide) and sample 6 (Salt + High Ammonia + Sulfide) were used as representative samples. Sample 4, it will be remembered, contained widely spaced pits slightly larger than sample 3 (Figures 10 and 11). Figure 17 shows a representative pit from sample 4 with the

result would naturally be that not only the original Cu_2S sites are available for pitting, but also the sites where Cu_2S has formed due to the weakening or dissolution of the Cu_2O film. The net result would be an increase in the number of corrosion sites, precisely what was observed (compare Figures 10 and 11). In this way, it is possible for ammonia to dramatically effect the extent of corrosion, yet in no way become incorporated into the corrosion films observed. This was seen for all samples with ammonia, and the explanation above is only a first order attempt to formulate a mechanism for the synergistic effect of ammonia in conjunction with sulfide.
